# Material Deterioration Detection of Wooden Columns at the Nanyang Fuya Museum Using a Combination of Macroscopic Visual Inspection and Moisture Content Testing

Yan Yang,\* Chungse Song, Limei Liang, Minghui Tao, Fuqun Wang, and Ying Zhao

*Keywords:* Nanyang Fuya Museum; Wooden column; Material deterioration detection; Macroscopical visual inspection; Moisture content testing

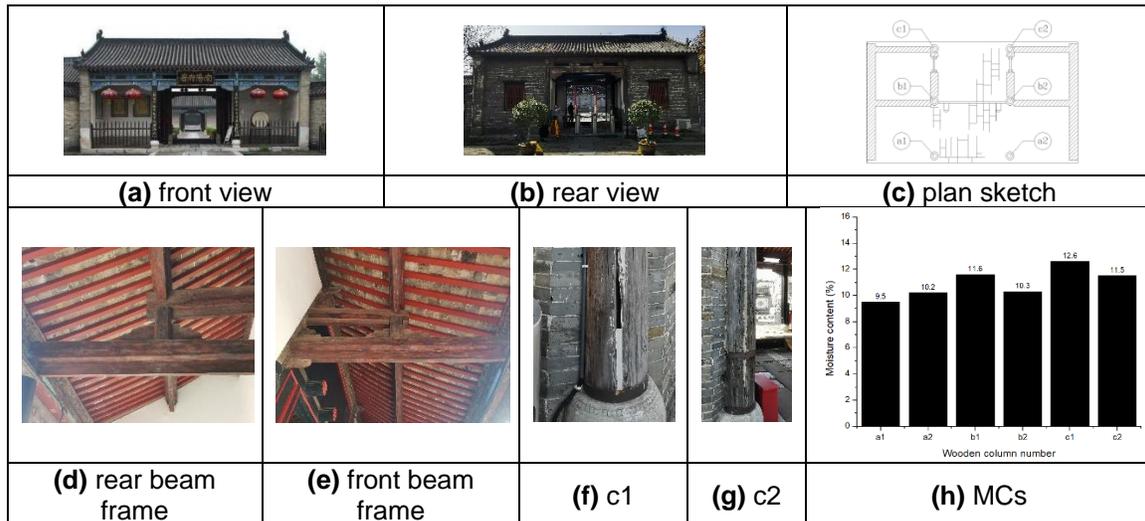
Fig. 2. Material deterioration and MCs of wooden columns in the Entrance Door

The Entrance Door, which has three rooms in width and two rooms in depth, is a five-purlin hard mountain building. It contains two front eave columns, two rear eave columns, and two central columns that are circular (Figs. 2 (a)-(c)). Central and front eave / rear eave columns are connected by double stepping crossbeams with beam fangs, and short columns are placed on the double stepping crossbeams (Figs. 2 (d)-(e)). Investigation has indicated no evident material deterioration in the two front eave columns (a1 and a2) and two central columns (b1 and b2). Nevertheless, significant cracks with width and depth up to 20 mm and 100 mm, respectively, appeared in the two rear eave columns (c1 and c2) (Figs. 2 (f)-(g)).

MCs of all columns in the Entrance Door were below 13%, as shown in Fig. 2 (h). The result is primarily consistent with the equilibrium moisture content (EMC) of 12% of local timbers in Nanyang City. There were no blocks of tall buildings in front and back of

the Entrance Door, in which the space was comparatively vacant and the perennial lighting and ventilation effects were well maintained. When surrounding temperature increased and relative humidity declined, water of the interior wooden columns evaporated relatively rapidly into the air, achieving balance with the environment. Low MC of the wooden columns generally reduced the probability of decay. This condition is one of the main reasons why there was no apparent decay in all columns in the Entrance Door.

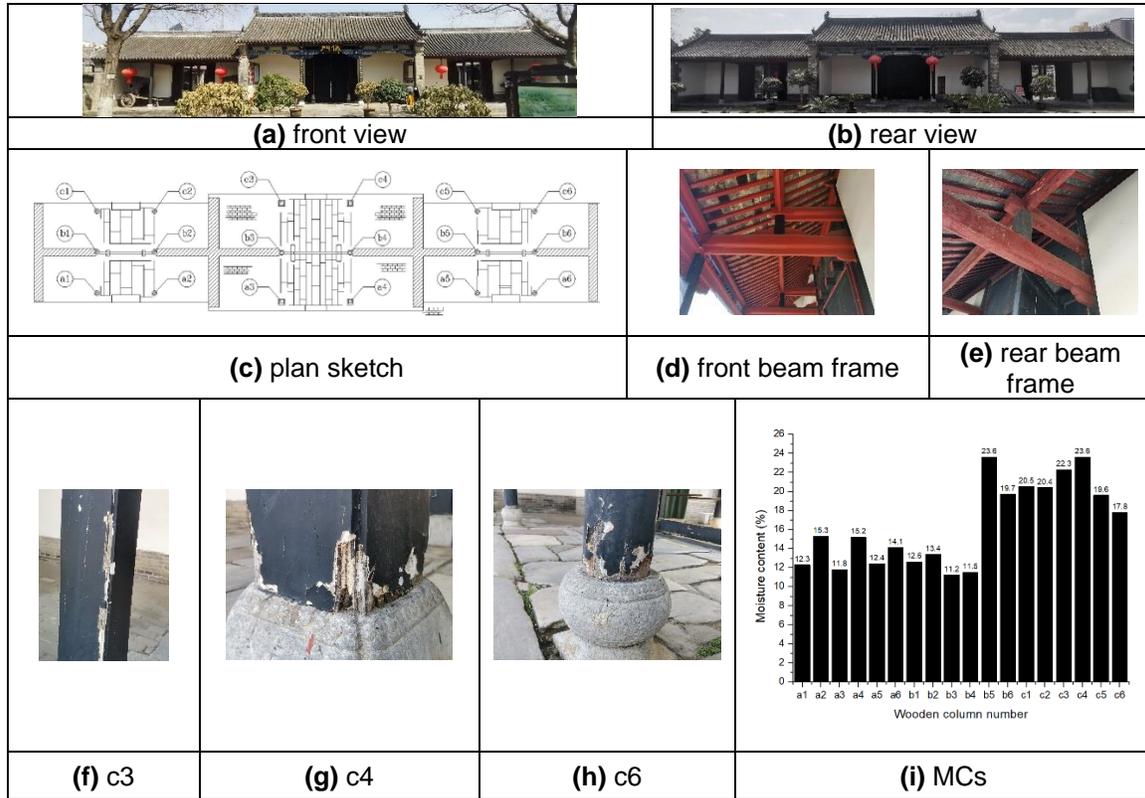
Fig. 3. Material deterioration and MCs of wooden columns in the Rite Door

The Rite Door and both sides of the barrier, which have three rooms in width and two rooms in depth, are all five-purlin hard mountain buildings. Except for the front and rear eave columns in the Rite Door, which are rectangular, the other wooden columns are circular (Figs. 3 (a)-(c)). Central and front eave/ rear eave columns are connected by double stepping crossbeams with beam fangs, and short columns are placed on the double stepping crossbeams (Figs. 3 (d)-(e)). Investigation has indicated that the wooden columns in the Rite Door and both sides of the barrier are decorated with black oil paint. A slight decay (Grade I) with decay height of about 100 mm was observed at the root of the right rear eave column (c4) in the Ming Room of the Rite Door. Parts of the surface oil paint decoration had different degrees of peeling. Most wooden columns had no evident material deterioration and are well preserved (Figs. 3 (f) and (h)).

Figure 3 (i) shows that MCs of the six front eave columns (a1-a6) and four central columns (b1-b4) in the Rite Door and both sides of the barrier were below 15.3%. Meanwhile, those of the two central columns (b5-b6) and six rear eave columns (c1-c6) were above 20%, among which those of columns b5 and c4 were up to 23.6%. Accordingly, there was a high decay risk. The Rite Door is 26-m away from the Entrance Door and 54.5-m away from the Great Hall. There were no blocks of tall buildings in front and rear of the Rite Door building, and the space was comparatively vacant with good lighting and ventilation effects throughout the year. Although MCs of the central and rear eave columns were comparatively high, water in the interior columns was gradually equilibrated with that in the environment, which considerably decreased the probability of decay. This condition is one of the main reasons why no apparent decay was discovered in all columns in the Rite Door.

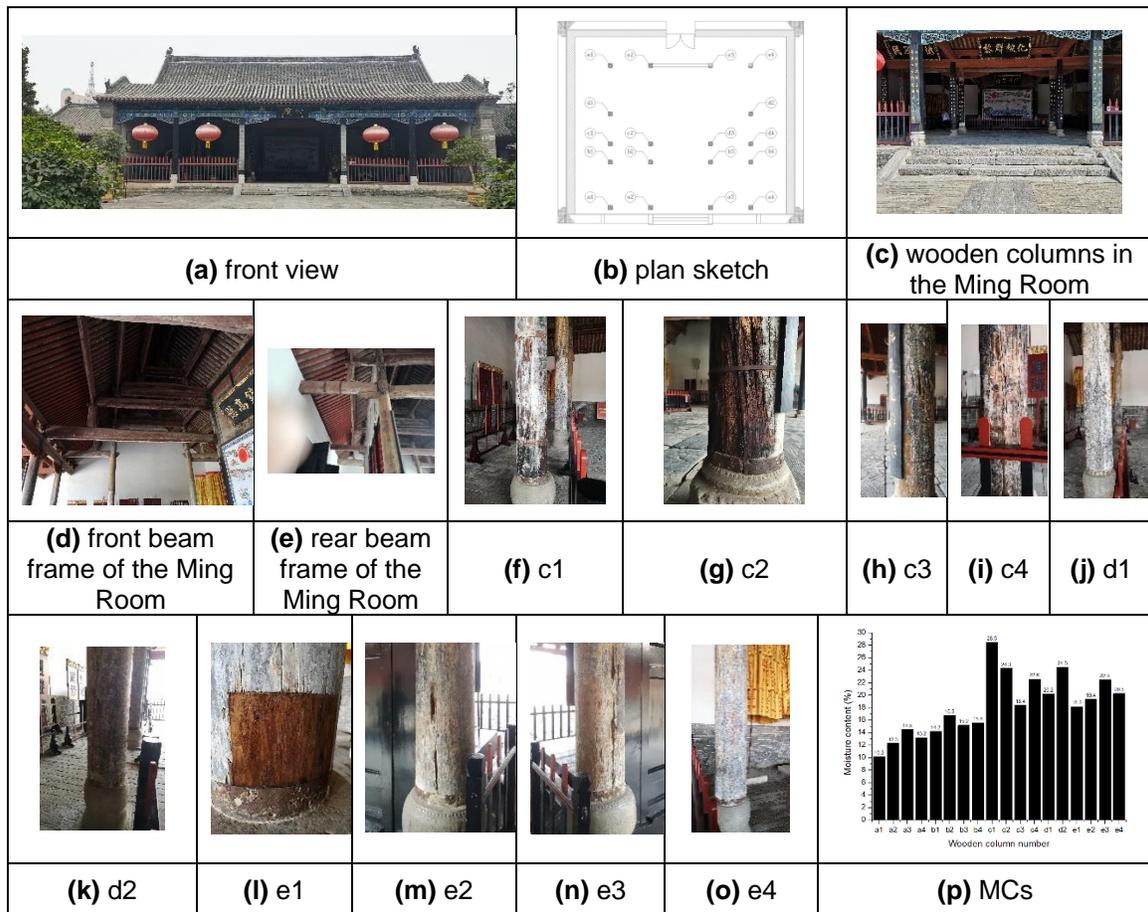
Fig. 4. Material deterioration and MCs of wooden columns in the Great Hall

The Great Hall is composed of the front roll shed building and rear hard mountain building, with five rooms in width and three rooms in depth (Fig. 4 (a)). All wooden columns are circular, except for the front eave columns in the front roll shed building, which are rectangular. Column reduction was adopted in the front golden column in the Ming Room of the rear solid mountain building, thereby substantially expanding the internal space (Figs. 4 (b)-(c)). There are six-step crossbeams between the front eave and rear golden columns, and double stepping crossbeams between the rear golden columns and the rear wall are adopted (Figs. 4 (d)-(e)). The current investigation revealed that the surfaces of eave columns, which contain four front eave and four rear eave columns (a1-a4, b1-b4) in the front roll shed building, are painted with black oil paint decoration. No evident material deterioration was detected, except for some black oil paint decoration falling off (Figs. 4 (a) and (c)). Material deterioration and MCs of wooden columns in the hard mountain building was more evident and severe. Root decay instances of front eave columns c1 and c2 were serious (Grade III) with decay height of up to 600 mm. Pier connection technology was adopted at the root of front eave column c1, and surface decay area of column c2 root reached over 1/2 of its surface area (Figs. 4 (f) and (g)). Medium decay (Grade II) was found on the surfaces of front eave columns c3 and c4 and has been repaired using the patching method (Figs. 4 (h) and (i)). No evident decay was observed, but some small cracks were revealed in front golden columns d1 and d2 (Figs. 4 (j) and (k)) and rear golden column e4 (Fig. 4 (o)). The root of rear golden column e1 was decayed severely (Grade III), and the embedded package method was adopted (Fig. 4 (l)). Local decay (Grade II) was observed on the surfaces of rear golden columns e2 and e3, and local removal treatment was adopted (Figs. 4 (m) and (n)).

As shown in Fig. 4 (p), MCs of the eight front and rear eave columns (a1-a4, b1-b4) of the roll shed in front of the Great Hall were maintained below 16%. In the four front eaves columns (c1-c4), two front golden columns (d1, d2), and four rear golden columns (e1-e4) of the hard mountain building in the rear of the Great Hall, MCs were above 20%, among which column c1 was as high as 28.5% with high decay risk. Exceptions were columns c3, e1, and e2 which had much lower MC. This condition is one of the main reasons for the serious decay of the wooden columns.

MCs of the wooden columns in the front roll shed were considerably lower than those in the rear hard mountain building. The following reasons are presented. ① The eight eaves columns in the front roll shed are located in the south direction, and the perennial temperature is higher than that in the north direction. ② The Great Hall is 54.5-m away from the Rite Door. There are no blocks of tall buildings in front of the Great Hall, so the space is comparatively vacant. Similarly, there is no wall in front of the Great Hall, so the ventilation effect is maintained year-round. ③ Surfaces of the eight eave columns in the front roll shed were painted with black oil paint, which also prevented water from entering. Nevertheless, the hard mountain building is located on the shady side of the Great Hall, and the general lighting effect is insufficient. In addition, the hard mountain building is only 3.15-m away from the rear Yin Gong Door, so the ventilation effect is considerably inferior to the rolling shed. Studies (Chen *et al.* 2018) have indicated that water in the air

easily led to the formation of condensed water on the surface of stone column foundation due to the cooling of steam in the air. If the ventilation effect around the wooden columns is poor, then the column roots will rapidly absorb the condensed water through capillary action and flow from the column root to the top along the timber pores.

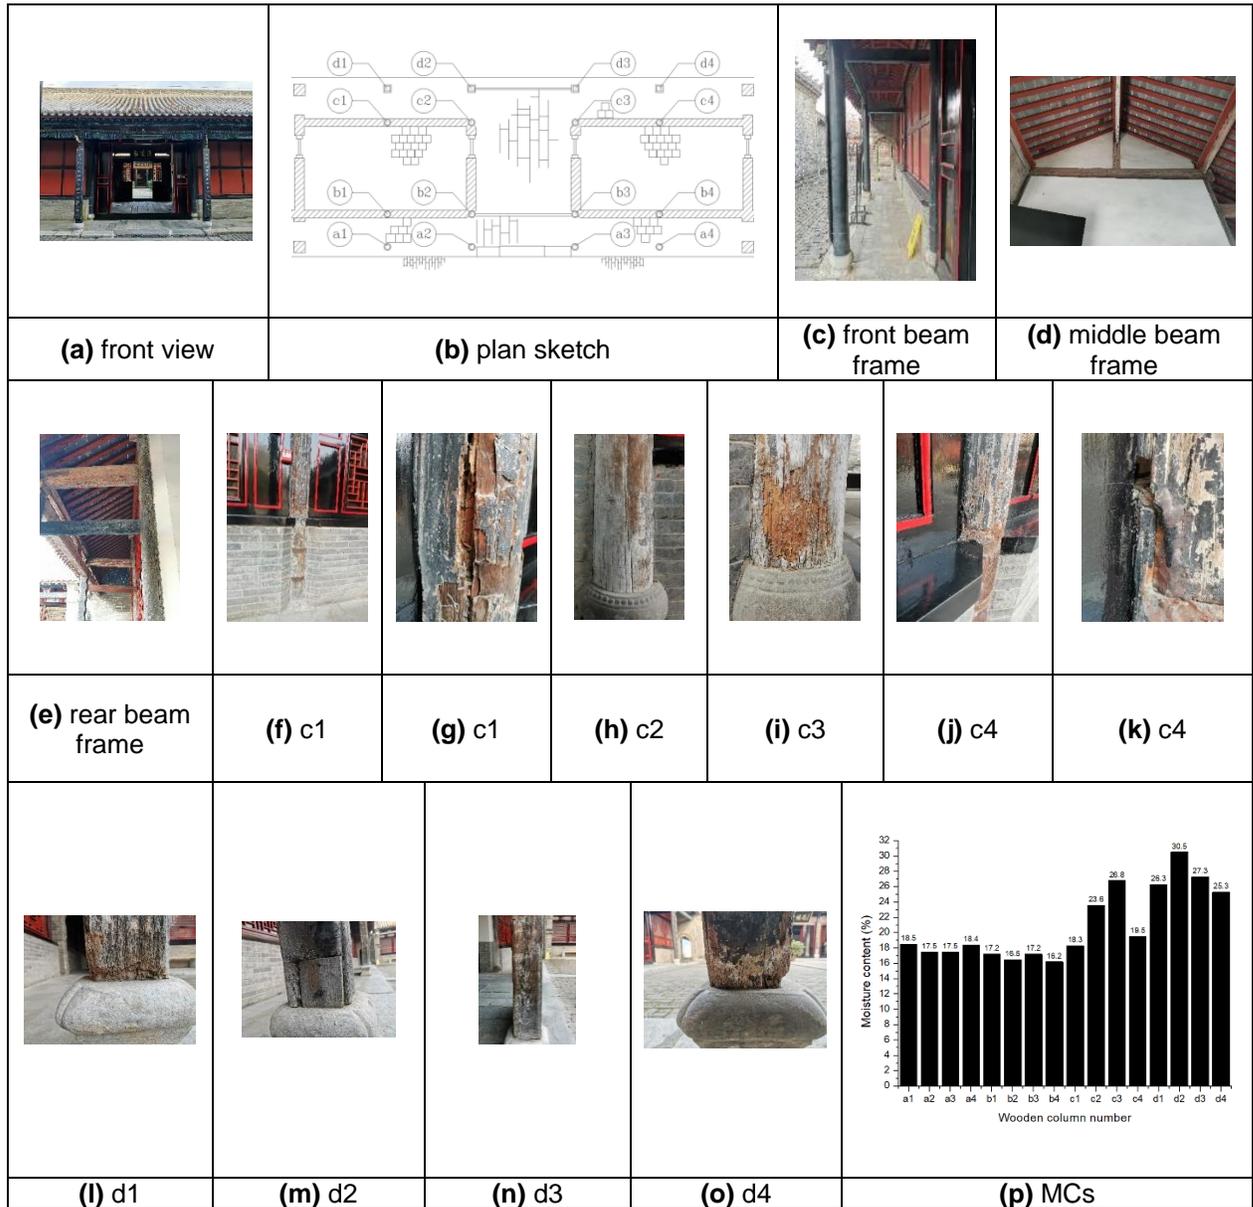
**Fig. 5.** Material deterioration and MCs of wooden columns in the Yin Gong Door

The Yin Gong Door, which has five rooms in width and three rooms in depth, is a five-purlin hard mountain building with front and rear corridors. It contains four circular front eave columns, four rectangular rear eave columns, and two rows of circular golden columns (Figs. 5 (a)-(b)). The front porch belongs to a roll shed gallery structure. Front eave and front golden columns are connected by tie beams, and there are double stepping crossbeams on the tie beams. The beam structure between the two golden columns is a three-frame beam, three-frame beams support short columns, short columns directly bear the ridge purlins, and there are purlin beams under the ridge purlins. Rear eave and rear golden columns are connected by tie beams and single stepping crossbeams (Figs. 5 (c)-(e)). The current investigation detected that the surfaces of the four front eave columns (a1-a4) and the four front golden columns (b1-b4) of the Ming Room and secondary rooms are decorated with black oil paint. Nearly no evident material deterioration was discovered, except for some black oil paint decoration falling off (Fig. 5 (a) and (c)). The rear golden column (c1) in the western secondary room had serious overall decay (Grade III) with decay height of 1.5 m, there was evident pier connection repair treatment below 1 m, and there was a serious crack 20-mm wide, 425-mm long, and 40-mm deep in the middle part of column c1 (Figs. 5 (f)-(g)). The rear golden column (c2) on the western side of the Ming Room had no evident decay except for some small cracks (Fig. 5 (h)). Decay was highly evident at the root of the rear golden column (c3) on the eastern side of the Ming Room (Grade II), and the decayed area accounted for about 1/3 of the surface area (Fig. 5 (i)). The rear golden column (c4) in the eastern secondary room had serious overall decay (Grade III), there was evident pier connection repair treatment, and there was a large hole at the pier connection position (Figs. 5 (j)-(k)). Significant decay instances were found at the roots of the rear eave column (d1) in the western secondary room (Fig. 5(l)) and rear eave column (d4) in the eastern secondary room (Fig. 5 (o)). Moreover, ratio of the actual bearing area between the bottom surface of the column and the column base to the original section area of the column foot was about 4/5 (Grade III). The root of the rear eave column (d2) on the western side of the Ming Room was significantly decayed (Grade III), the embedded package method was adopted for the local decay, and a large knot defect was found at the column root (Fig. 5 (m)). The overall surface of the rear eave column (d3) on the eastern side of the Ming Room was significantly decayed (Grade III) (Fig. 5 (n)).

As shown in Fig. 5 (p), MCs of the four front eave columns (a1-a4) and the four front golden columns (b1-b4) in Yin Gong Door remained at 16% to 19%, which was considerably higher than those of the two front eave columns (10% to 15%) in the Entrance Door and Rite Door. MCs was above 20%, except for columns c1 and c4 in the four rear golden columns (c1-c4) and four rear eave columns (d1-d4), and what calls for special attention is that MC of column d2 was as high as 30.5%, facing high decay of risk. Decay degrees of the wooden columns in Yin Gong Door were considerably greater than those of the front Entrance Door and Rite Door (Figs. 2-4). There are two main reasons for this result. ① Perennial light duration of Yin Gong Door is insufficient. Yin Gong Door is only 3.15-m away from the front Great Hall, the height of which is markedly higher than Yin Gong Door, making it almost always in a shady environment, further resulting in lower

surrounding temperature and higher relative humidity. ② Ventilation effect of Yin Gong Door is comparatively poor because of a relatively closed quadricle courtyard formed by Yin Gong Door, the rear Secondary Hall, and the east and west wings. Condensed water formed on the surface of the stone column foundation cannot be rapidly evaporated. Hence, the wooden column roots can rapidly absorb this part of the condensed water through the capillary effect, consequently enhancing MCs of the column roots.

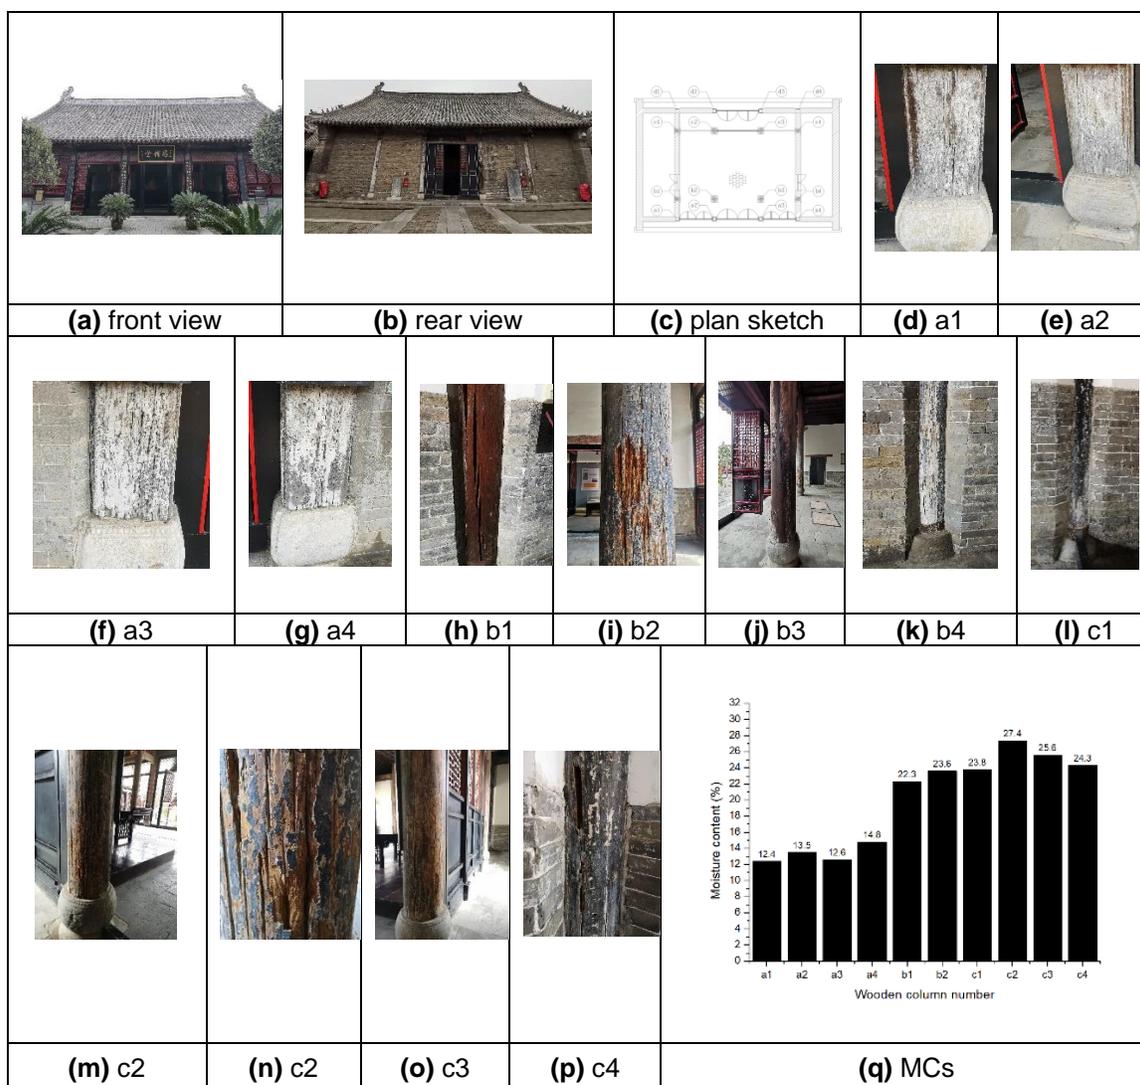
Fig. 6. Material deterioration and MCs of wooden columns in the Secondary Hall

The Secondary Hall is a seven-purlin hard mountain building with five rooms in width and three rooms in depth, and contains four rows of columns (four front eave, four front golden, four rear golden, and four rear eave columns). The front and rear eave columns are rectangular, and the front and rear golden columns are circular (Figs. 6 (a)-(c)). The eave columns and golden columns are linked by the main aisle exposed tiebeam, the beam structure between the two golden columns belongs to five-frame beam, there are tiebeams under the beam, five-frame beams support short columns, short columns bear three-frame beams, and purlins are erected on each beams. There is a ceiling on the five-frame beam. The present investigation indicated that the oil paint on the surfaces of the four front eave columns (a1-a4) (Figs. 6 (d)-(g)) and the four rear eave columns (d1-d4) (Fig. 6) (b) has chipped off to varying degrees. Although no decay phenomenon was discovered, the different degree of weathering was evident.

The weathering characteristics are as follows: surfaces become rough and color turned gray and white, among others. The reason is that the front eave columns are located in the south direction, and the lignin of the columns resulted in photodecomposition under ultraviolet light for a long time. Norrstrom (1969) revealed that the extent of UV absorption of lignin in timber can reach 80% to 95% and that of carbohydrates from 5% to 20%. Therefore, coating the surface of wooden components can successfully reduce the photochemical decomposition of lignin and ultimately reduce damage to wooden components under long-term light conditions. The front golden column (b1) in the western secondary room had some extreme dry shrinkage cracks with width, depth, and length of 20, 60, and 120 mm, respectively (Fig. 6 (h)). Dry shrinkage cracks would lead to the reduction of shear capacity along the grain of wooden components, resulting in a risk of splitting of wooden components and the entire building structure after reaching a certain depth (Cabaleiro *et al.* 2017). In addition, the presence of dry shrinkage cracks would lead to the easy entry of rain water and fungi into the wooden components, consequently accelerating the decay of wooden components (Chen 2019). The left front golden column (b2) and right front golden column (b3) in the Ming Room were severely decayed (Grade III). The right front golden column (b3) has been repaired using the patching method, with the patching height up to 1.8 m (Figs. 6 (i)- (j)). There were many insect holes on the surface of the left rear golden column (c2) in the Ming Room, demonstrating that insect erosion was severe. Decay was also exceptionally severe (Grade III), with the decay height over 1 m and the decay area accounting for about 3/4 of the surface area. Part of the severe decays were repaired using the patching method (Grade III) (Figs. 6 (m)-(n)). The surface of the right rear golden column (c3) in the Ming Room was evidently decayed, with decay height of 800 mm (Grade II) and some small cracks (Fig. 6 (o)). Local decay appeared on the surface of the rear golden column (c4) in the eastern secondary room, and local decay was removed (Grade I) (Fig. 6 (p)). Nevertheless, no evident decay was discovered in the front golden column of the eastern secondary room (b4) (Fig. 6 (k)) and the rear golden column of the western secondary room (c1) (Fig. 6 (l)).

As shown in Fig. 6 (q), MCs of the four front eave columns (a1-a4) in the Secondary Hall (Si Bu Tang) remained at 13% to 17%. MCs of the four front golden columns (b1-b4) and four rear golden columns (c1-c4) were above 20%. Note that MC of column c4 was as high as 28.9%. The four rear eave columns (d1-d4) had no evident decay phenomenon on the surface, but MCs were above 20%. Note that MC of column d1 was as high as 41.2%, with a comparatively high risk of decay. The Secondary Hall (Si Bu Tang) was surrounded by walls. The four front golden columns (b1-b4), four rear golden columns (c1-c4), and four rear eave columns (d1-d4) formed a comparatively closed environment. Moreover, ventilation effects and light conditions were not as good as the front eave columns (a1-a4), which were located in the south direction and well-ventilated. Hence, MCs of the columns retained relatively higher and the deterioration phenomenon was more evident. Compared with the four front eave columns (a1-a4) in the roll shed building of the Great Hall, MCs of the four front eave columns (a1-a4) in the Secondary Hall (Si Bu Tang) were 2% to 3% higher than those in the roll shed building of the Great Hall. The reason may be that none of the oil paint coating (Fig 6 (d)-(g)).

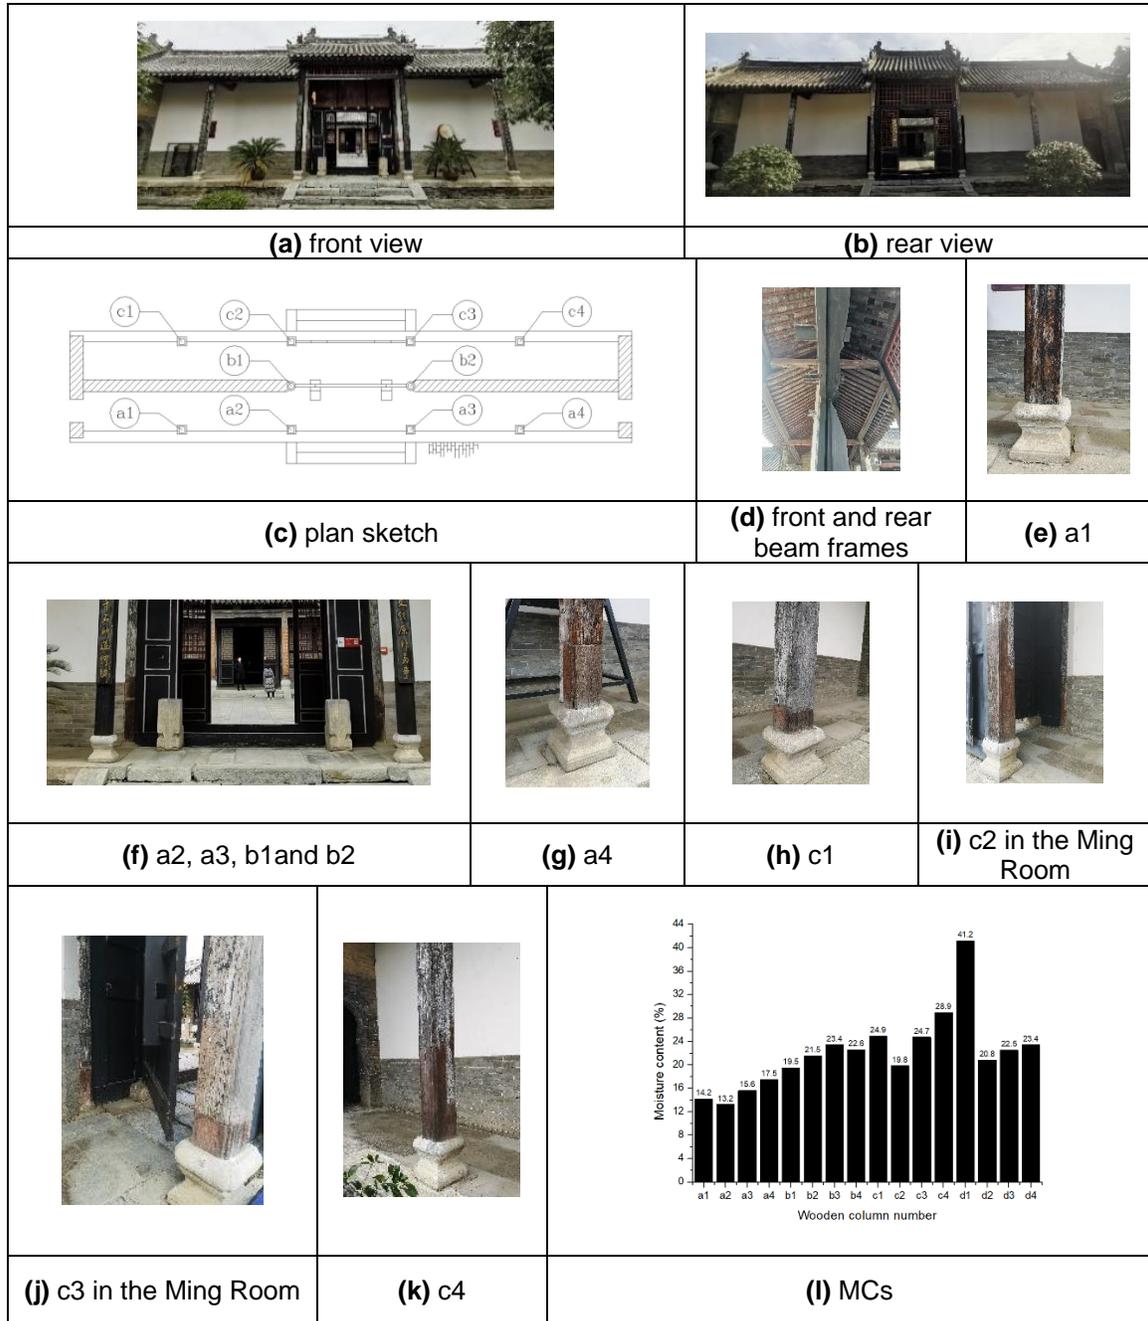
Fig. 7. Material deterioration and MCs of wooden columns in the Screen Door

The Screen Door, which has five rooms in width and two rooms in depth, is a three-purlin hard mountain building. The front and rear eave columns are rectangular, while the two central columns in the Ming Room are circular (Figs. 7 (a)-(c)). Front/rear eave

columns and central columns are connected by single stepping crossbeams, and there are eave purlins on the single stepping crossbeams. The roof of the Ming Room is 0.65-m vertically higher than that of the secondary rooms on the left and right (Figs. 7 (a)- (d)). Investigation has indicated that the surface of the front eave column (a1) in the western secondary room indicated slight decay (Grade I) (Fig. 7 (e)). Surfaces of the front eave columns (a2 and a3) in the Ming Room were painted with black oil paint decoration, and there was no evident material deterioration except part of the oil paint decoration falling off from the surfaces (Fig. 7 (f)). The front eave column (a4) in the eastern secondary room (Fig. 7 (g)) and the two central columns in the Ming Room (b1 and b2) (Fig. 7 (f)) were seriously decayed (Grade III), the front eave column (a4) had evident embedded package method, while columns b1 and b2 had pier connection technology with a pier connection height over 600 mm. All four rear eave columns (d1-d4) were seriously decayed (Grade III) to differing degrees. Among them, the roots of the rear eave column (c1) in the western secondary room (Fig. 7 (h)) and east rear eave column (d3) in the Ming Room (Fig. 7 (j)) had an evident embedded package method with height of about 300 mm. The roots of the western rear eave column (d2) in the Ming Room (Fig. 7 (i)) and eastern rear eave column (d4) in the eastern secondary room (Fig. 7 (k)) were repaired by pier connections with pier connection heights of 900 mm in column d2 and 500 mm in column d4.

As shown in Fig. 7 (l), MCs of the four front eave columns (a1-a4) in the Screen Door were kept below 15%. MCs of the two central columns (b1-b2) and four rear eave columns (c1-c4) were above 22%, among which that of column c2 was up to 27.4%, with a comparatively high decay risk. The Screen Door is 18-m away from the Secondary Hall and the space is comparatively vacant. The four front eave columns (a1-a4) are located in the south direction without wall shielding, in which perennial lighting and ventilation effects were retained well. In addition, surfaces of the columns were protected by black oil paint decoration, which kept MCs comparatively low. The Screen Door, tertiary hall, and the east and west wings of the Tertiary Hall formed a comparatively closed quadrangle, and the ventilation effect was relatively poor. In addition, the two central columns (b1-b2) and four rear eave columns (c1-c4) were in the shade, and the lighting conditions were not as good as the front eave columns (a1-a4). Thus, MCs of the columns were comparatively high.

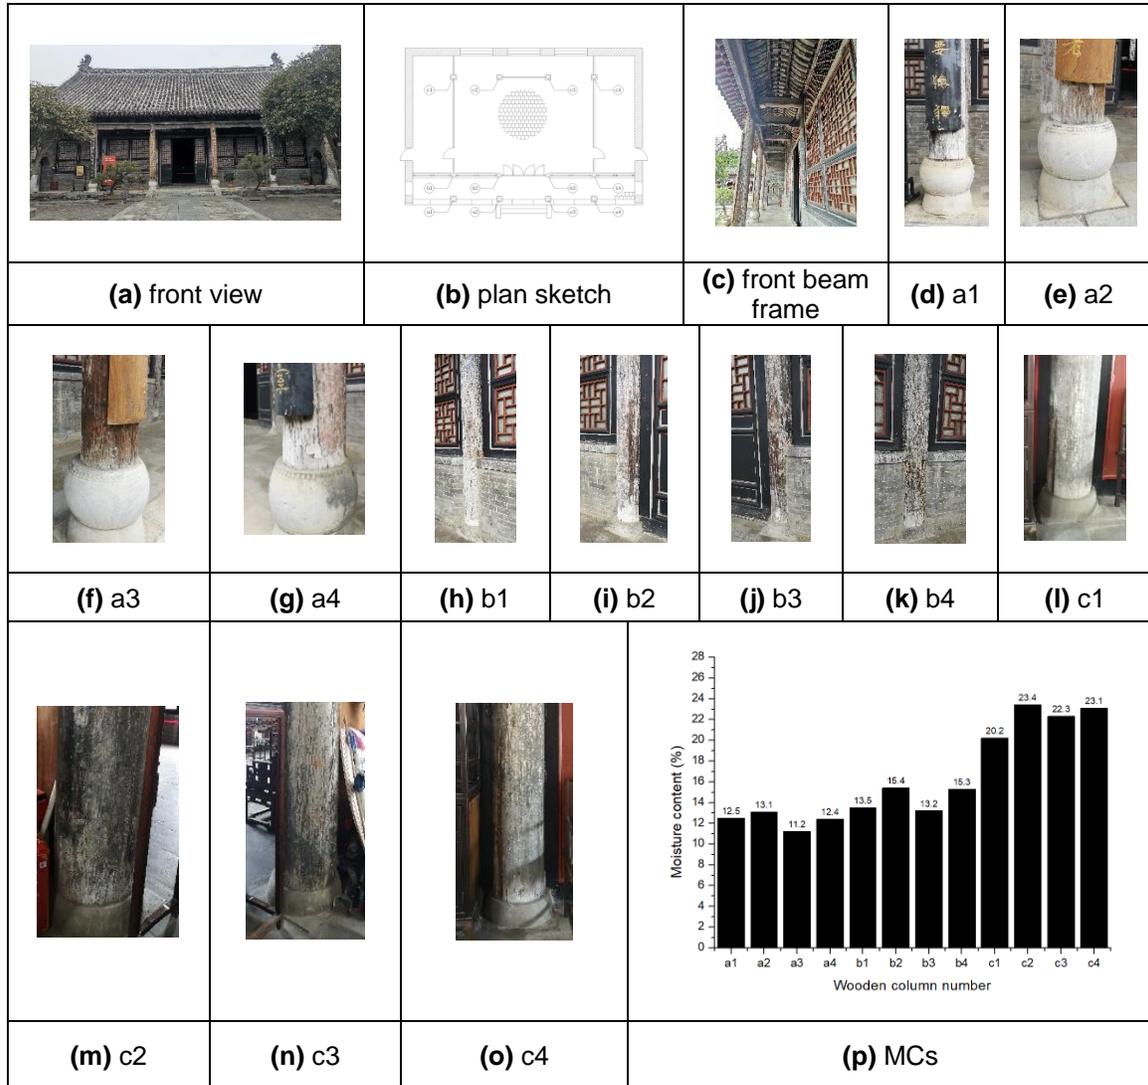
**Fig. 8.** Material deterioration and MCs of wooden columns in the Tertiary Hall

The Tertiary Hall is a seven-purlin hard mountain building with five rooms in width and three rooms in depth. It contains three rows of columns: four front eave columns, four front golden columns, and four rear golden columns. All columns are circular (Figs. 8 (a)-(c)); the front eave corridor belongs to a roll roof shed. The front golden columns and front eave columns are connected with baotou beams (Fig. 8 (c)), and the rear golden columns and rear wall are connected with single stepping crossbeams. The status survey indicated that wood oil paints on the surfaces of the four front eave columns (a1-a4) (Figs. 8 (d)-(g)) and the four front golden columns (b1-b4) (Figs. 8 (h)-(k)) almost fell off. Although no evident decay phenomenon was discovered, various degrees of weathering were marked because of the photodecomposition of the lignin of wooden components under ultraviolet light for a long time. Slight decays have shown in the four rear golden columns c1 and c4 (Grade I), while columns c2 and c3 were fundamentally well preserved (Figs. 8 (l)-(o)).

As shown in Fig. 8 (p), MCs of the front eave columns (a1-a4) and front golden columns (b1-b4) in the Tertiary Hall (Yan Si Tang) were retained below 15%, while those of the rear golden columns (c1-c4) were maintained at 20% to 24%. Ventilation and illumination conditions of the golden columns (c1-c4), which were in a relatively closed environment because of the surrounding of the four walls, were worse than the front eaves columns (a1-a4) and front golden columns (b1-b4). Although there was no apparent decay phenomenon, as shown in Fig. 8, MCs remained high, and there was still a high decay risk. In addition, oil paint decorations on the surfaces of all wooden columns fell off to different degrees. Without the protection of oil paint decorations, the possibility of absorbing moisture from the air was considerably enhanced, thereby possibly further leading to an increase of MCs and enhancement of the decay risk of wooden columns.
