Assessment of Termite Damage in Cross-laminated Timber Sections Using Micro-computed Tomography and Vibration Analysis

Keywords: Termite damage; Engineered wood products; Microcomputer tomography; Vibration analysis; Mass loss

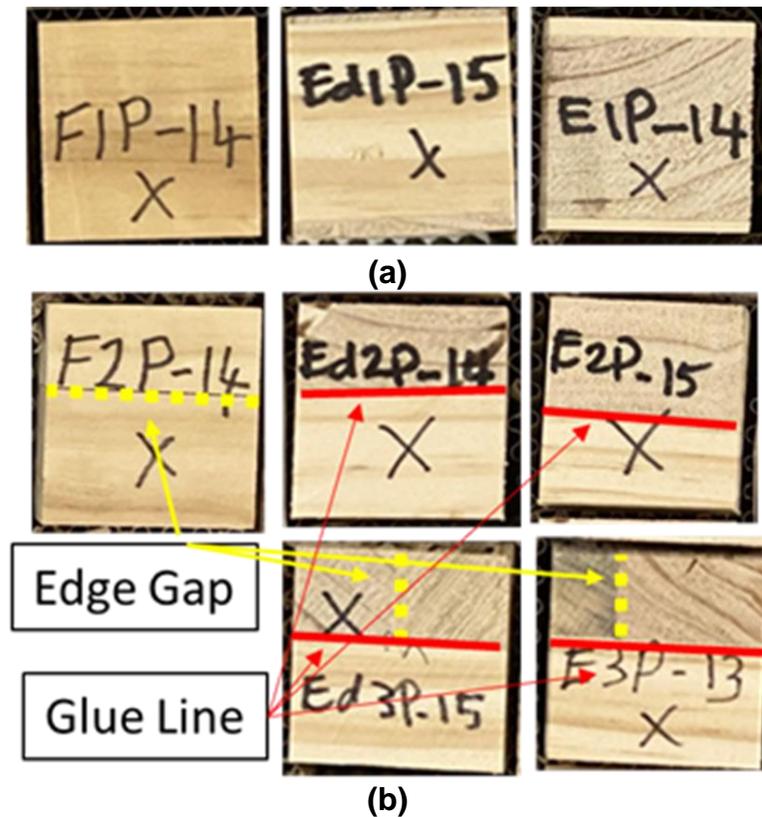
Fig. 1. (a) Section with no edge gap or glue line (1P- one piece), (b) section with glue line (in end or edge directions) or edge gap (in face direction) (2P- 2 piece) and section with glue line and edge gap (3P- 3 piece)

The blocks were cut from different sections of the CLT board, resulting in 7 different configurations each with a different degree of edge, end, and face exposure (Fig. 1 (a) and (b)). A total of 420 samples were split into 20 boxes, with each box containing all 7 configurations of 3 samples per configuration (21 samples per box). An additional 24 samples were cut as control samples from each configuration. This was done purely for easy identification to be μ -CT scanned after the field trial. The control samples were then split randomly into 12 boxes after scanning to then be placed in moisture conditioning chambers. To examine the effects of initial moisture content (MC) on termite damage, the first 10 boxes were placed in an 8% moisture conditioning chamber (23 °C and 55% RH) and the remaining 10 conditioned in a 12% moisture conditioning chamber (22 °C and 60% RH). Once the samples were conditioned to the desired MC, the individual dimensions and weight were recorded.

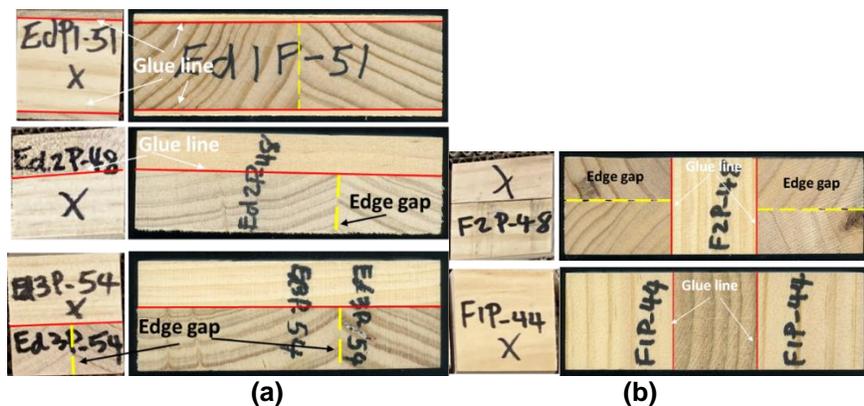
Fig. 2. Sample types used for the termite exposure trial with details of edge gap and glue lines, (a) edge and end directions (E- Edge and Ed- End) and (b) face direction

The harvested samples (Fig. 2) were then placed in the freezer to halt termite activity. The termite debris and residue were then cleaned off the samples, collected in bags, and samples were placed in the respective conditioning chambers (Fig. 3). The samples were then measured and weighed after re-conditioning.

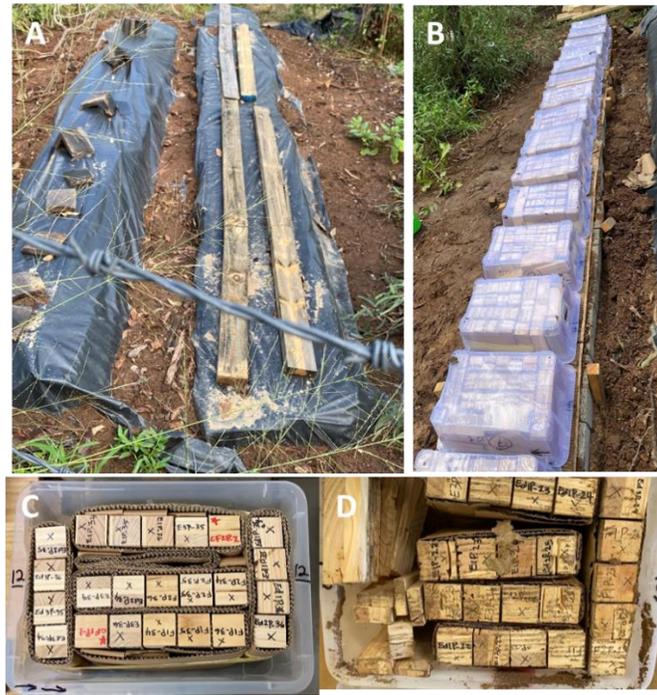
Fig. 3. (A) Trench used for exposing samples to termite foraging, (B) sample boxes placed in the trench for the period of exposure to termite foraging, (C) samples packed in cardboard sections and placed in boxes to be exposed to termite attack, and (D) harvested sample box after termite exposure

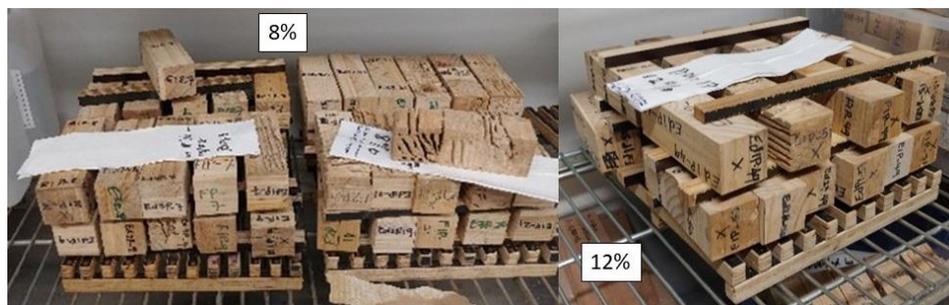
Fig. 4. Harvested and cleaned samples placed in the conditioning chamber at 12% and 8% MC before any further measurement and analysis

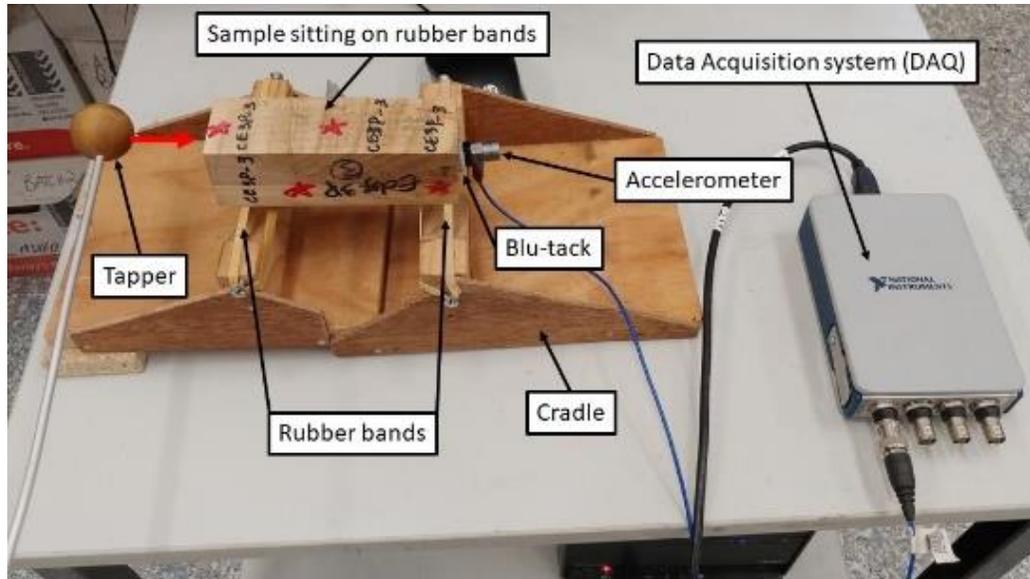
Fig. 5. Vibration test setup including the sample holder and impactor used

The samples were then placed on a cradle (Fig. 5) developed to produce a freely supported setup (weightless) and tap tested and measured with an accelerometer (Piezoelectric single axis) to obtain the impulse response to impact and the consequential frequency responses (Fig. 6).

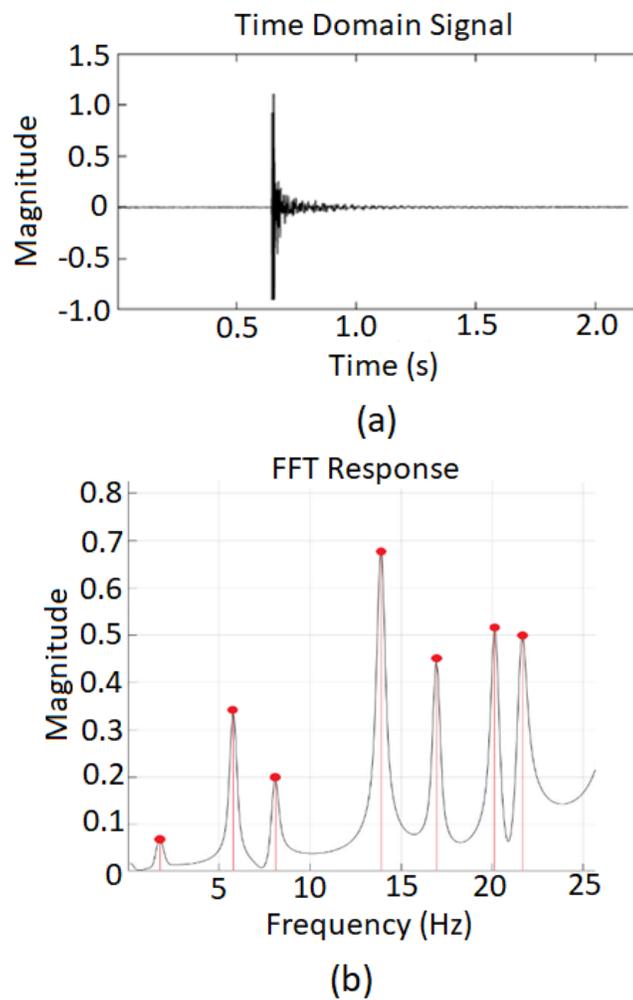
Fig. 6. Time (a) and frequency (b) response of the data process in MATLAB

From the response noted in Fig. 6, the frequency spectrum of each tested sample was evaluated for the number of amplitudes of the natural frequencies as well as the bandwidth of said frequencies to enable the determination of the quality factor (Eq. 1). Using a similar approach as presented by (Shirmohammadi *et al.* 2020, 2021).

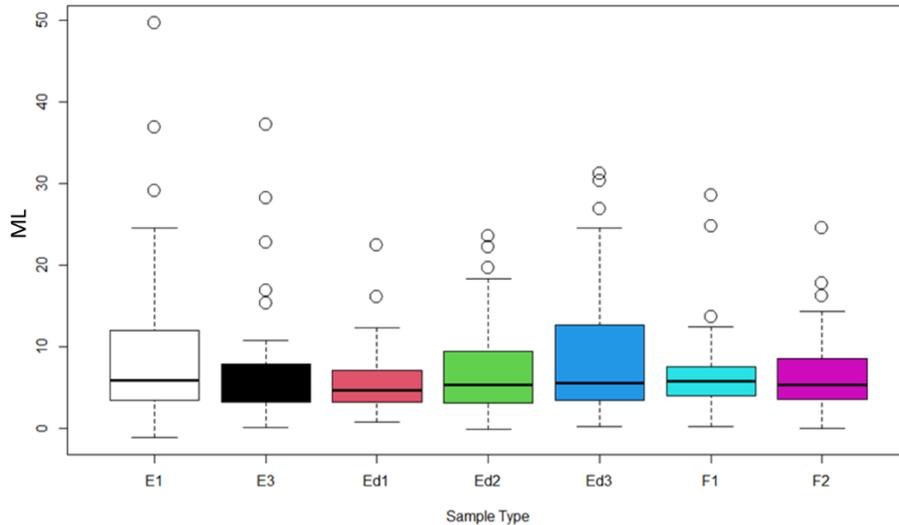
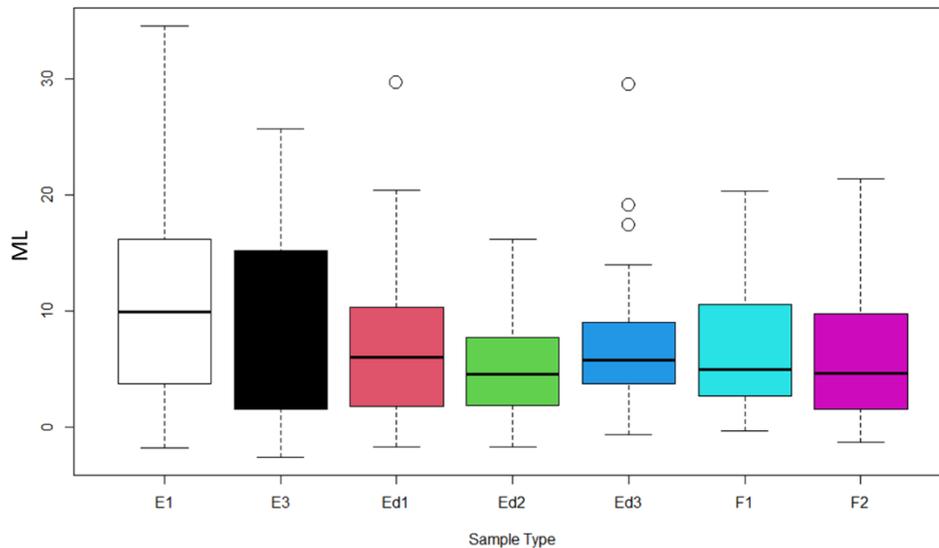
Fig. 7. Mass loss determined for samples at (a) 8% and (b) 12% MC after harvest. Graphs E, Ed, and F refer to Edge, End, and Face sections, respectively, and 1, 2, and 3 refer to 1-, 2-, and 3-piece sections. Bars show maximum and minimum values; the middle line shows the median and circles how the outliers.

Figure 7 shows the result of mass loss determined for samples with 8 and 12% initial MC after harvest. The overall summary of samples' mass loss showed a higher mass loss percentage in samples with 12% initial MC than samples with 8% initial MC.

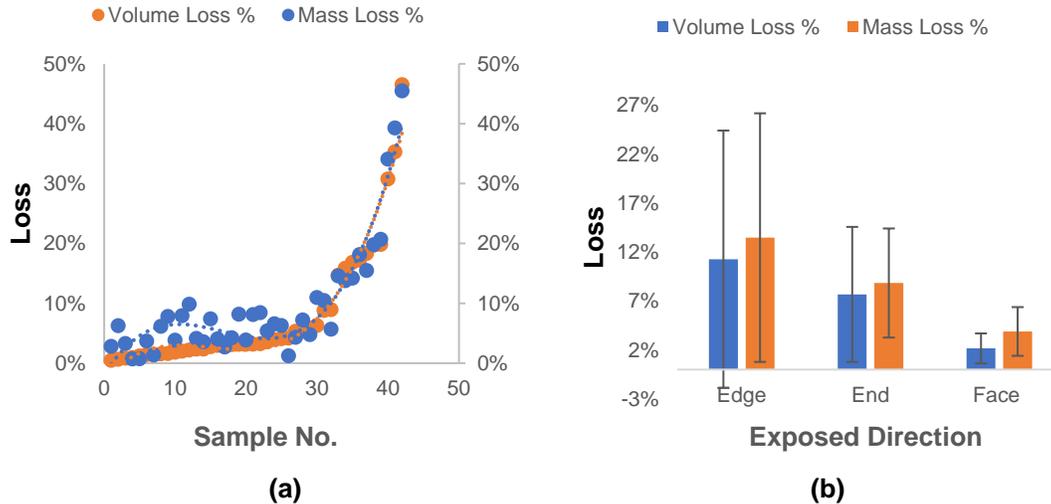
Fig. 8. Mass loss (ML) values determined from experiment and volume loss determined from 3D imaging scans where (a) shows the total distribution of mass and volume losses for samples tested, and (b) shows the breakdown of loss % across the three faces of samples that were exposed to termite damage

The volume loss determined from μ -CT imaging before and after the termite trial showed a similar pattern to mass loss determined by weighing the sample. The comparison between samples' exposed faces during the termite field trial (including face, end, and edge as shown in Fig. 8 (b)) showed higher mass loss values for samples with end grain exposed to the field conditions. Overall, face samples had a lower percentage of damage than the end and edge directions, showing the role of exposed end grain in termite damage.

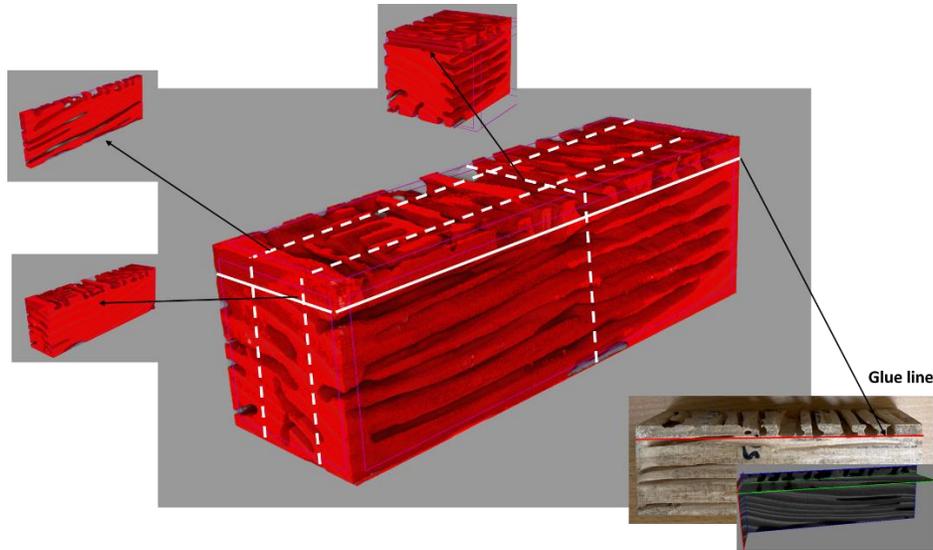
Fig. 9. Images of samples with glue line after exposure to termite trial

The 3D images taken showed that there were patterns of preference from the end grain section of sample blocks rather than the face sections (Figs. 9 to 11). This observation correlates well with the mass and volume loss data for each exposed direction (Fig. 9). The burrowing pattern observed when looking at the cross-section width- and length-wise showed that there was more obvious termite damage in the longitudinal cells (boards parallel to the lengthwise orientation).

The cell wall thickness, growth rings, and chemical composition of the timber affect the termite borrowing pattern where damaged channels along the grain direction of the samples have been observed (Himmi *et al.* 2016; Fauziyyah *et al.* 2019). The selectivity and continuous search for food sources within less dense and more desirable food types, including within growth rings, has been reported for subterranean and dry wood termites (Lee and Su 2009; Himmi, Yoshimura *et al.* 2016). A higher damage rate was also observed in EW sections than in the LW sections, as shown in Fig. 13. To study the effects of cell wall thickness, future scanning with higher resolution on sections with earlywood and latewood is recommended. Around the glue lines in multiple samples, the damage was observed on both sides of the line (Figs. 10, 12, and 13). The glue line seemed to act as a barrier to termite damage. Further investigation is recommended to investigate the effects of species, glue line type, and thickness on delaying damage (Himmi *et al.* 2016; Bagheri *et al.* 2022). Some samples showed signs of the termites burrowing out of the glue lines, where the adhesive layer was followed in parallel direction as they burrow but then show signs of stopping a few microns after burrowing into the glue line (Fig. 9).

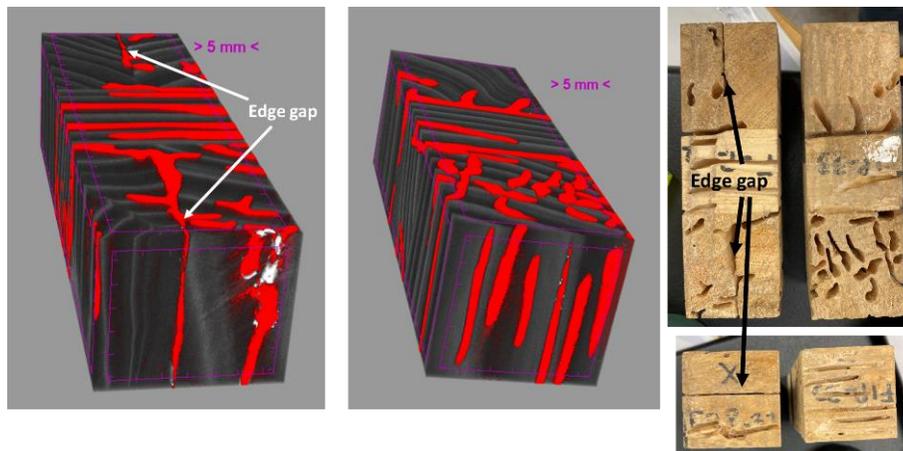
Fig. 10. Comparison of damage patterns in samples with edge and no edge gaps

Figure 10 shows samples of face sections with and without edge gaps. The edge gap created a pathway for termites to enter the sample block and develop damage patterns on both sides of the sample face, while the sample without an edge gap showed damage mainly on the exposed face to termites. Figure 11 shows damage following the growth rings with a higher tendency of damage created in earlywood bands. The damage on the side of the sample stops near the glue line, and more damage was observed on the other side of the glue line. From this observation, the glue line is acting as a barrier to further termite penetration with damaged pathways not going through it. This could be due to the adhesive type and the resistance it provides against termite (Bagheri *et al.* 2022)

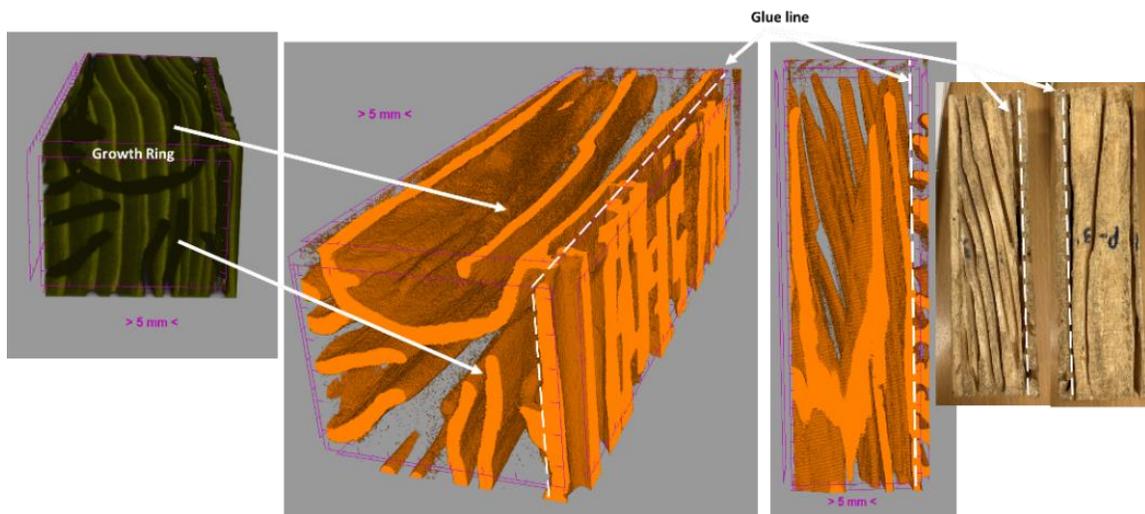
Fig. 11. Sample damage in the growth ring and damage patterns around the glue line

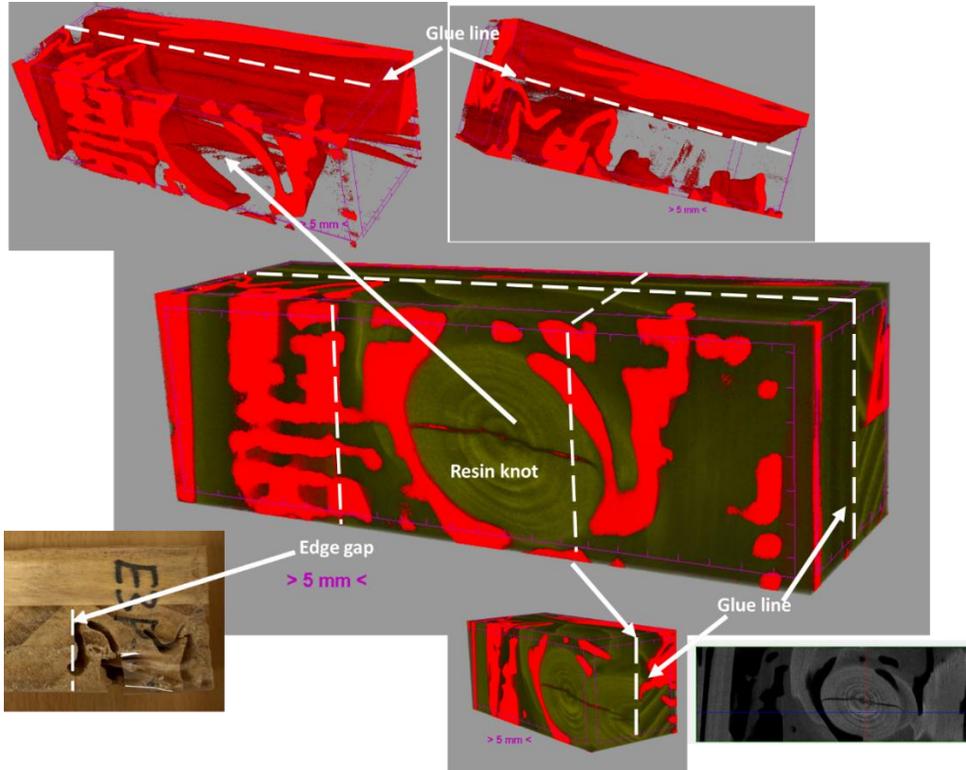
Fig. 12. Images of sample with resin knot and evidence of damage around the knot and the damages around the glue line

Figure 12 shows a sample with a resin knot; there were damaged sections around the resin knot without any damage going into the knot. The samples also exhibited damage near the glue line but not through the glue line, as presented in Fig. 10. A similar observation was reported by Himmi *et al.* (2016) where dry wood termites avoided the sections with knot in timber logs in their borrowing patterns.

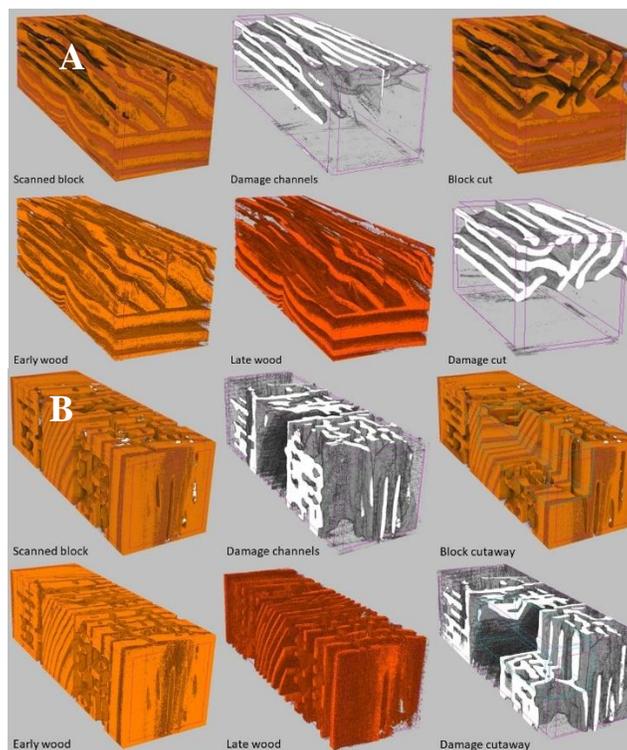
Fig. 13. 3D images of damaged sections with end grain exposed to termite (A) sample with end grain along the length and (B) sample with end grain along its width

Figure 13 represents the 3D images from reconstructed μ -CT scans with damage shown in different parts of the sample, including the longitudinal direction, as well as areas containing a higher proportion of EW to LW. Figures 13 (A) and (B) show the damage pattern continuing in the longitudinal cell direction. The damage continued through the cells along the entire length (Fig. 13 (A)) and width (Fig. 13(B)). Study of termite (*Coptotermes curvignathus*) attack patterns and penetration depth in untreated light Red Meranti (*Shorea spp.*) by Fauziyyah *et al.* (Fauziyyah *et al.* 2019) reported that observed termite galleries were similar to long flat tunnels that followed the grain direction of the wood.

Additionally, when the sample's exposed face had a portion of end grain (Fig. 13 (B)), there were more obvious damage patterns. The patterns showed that once the termites accessed the end grain face, the damage occurred through the entire width as a continuous channel, similar to what was observed by Fauziyyah *et al.* (2019) in samples with the end grain face exposed. The study showed the effects of cell wall thickness and the anatomical structure of samples in relation to termite gallery development (Fauziyyah *et al.* 2019).

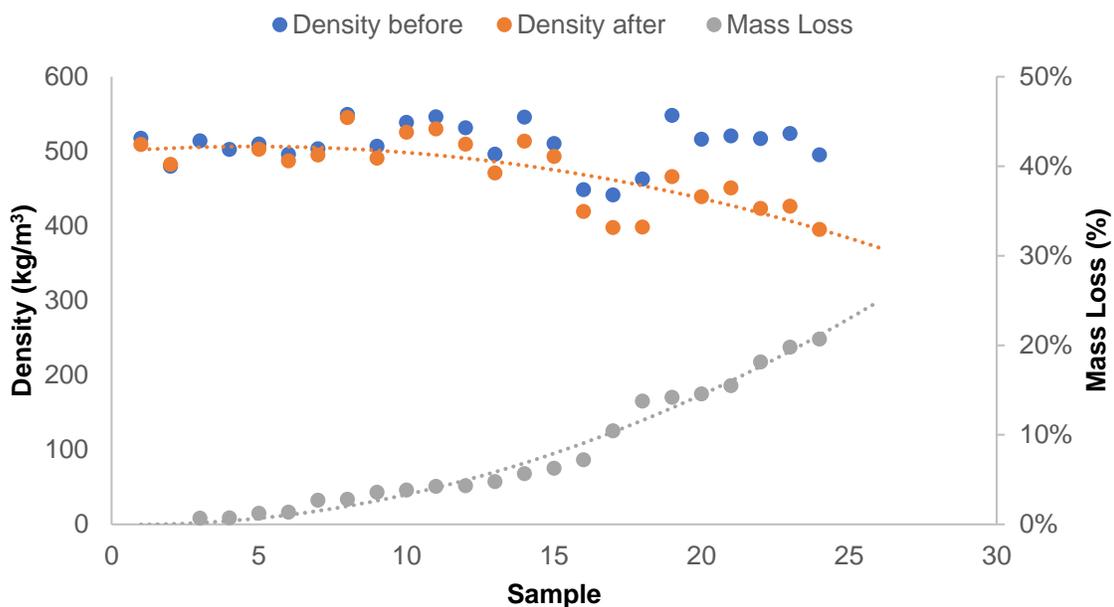
Fig. 14. Density of samples before and after termite trial, and the percentage of mass loss in samples due to termite damage

Figure 15 summarises the density variation in the samples after exposure to termite damage and the mass loss percentage determined for the samples. The results show a reduction in density and an increase in mass loss values. A similar trend was observed when vibration analysis was used to study the decayed CLT samples as the decay progressed and the percentage of damage increased. The variation in density was defined as a factor that the vibration NDE system can detect as the strength loss in the samples (Zhang *et al.* 2021).

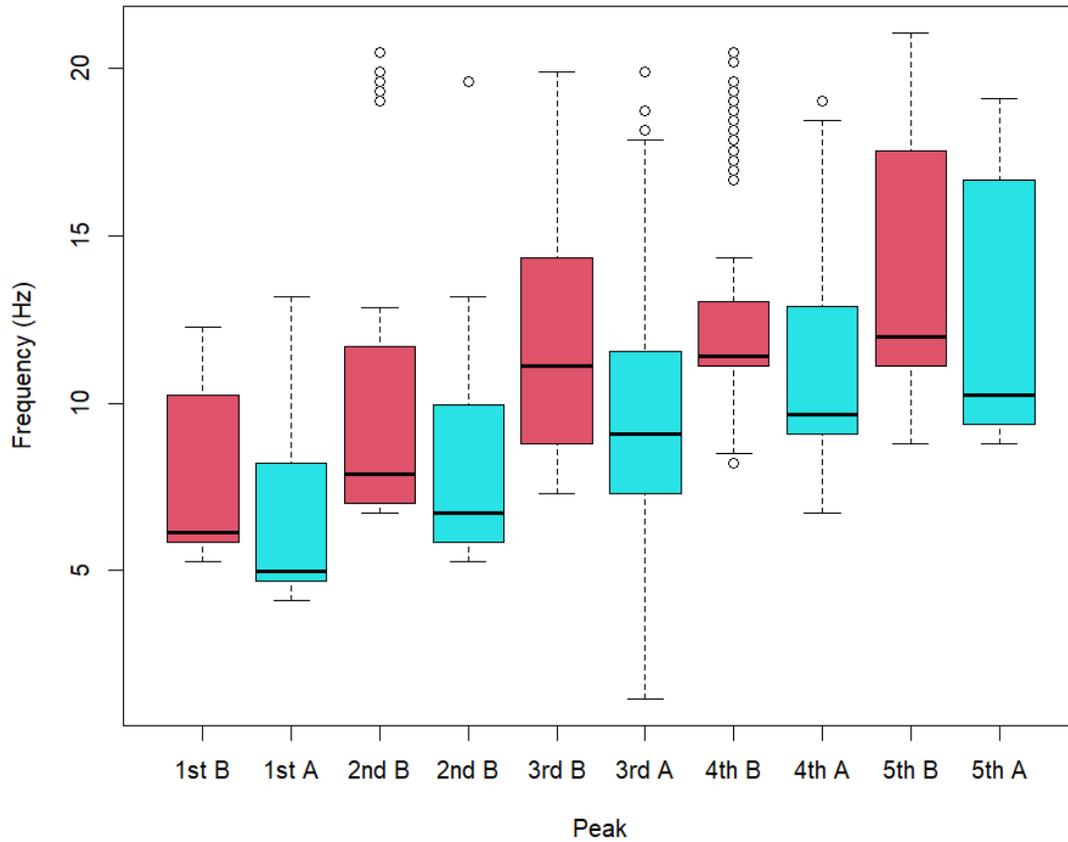
Fig. 15. Overall frequency peak values for samples tested before and after termite damage

Figure 16 summarizes the natural frequency peak values for samples tested before and after exposure to termite damage. As the termite damage progressed in the sample blocks, the frequency values were reduced compared to those determined on undamaged samples. The frequency values of all five peaks decreased after samples were exposed to termite damage. The decreased values can be used as the detection indicator for termite damage in the structure. A similar study on non-destructive assessment of decayed CLT sections using vibration analysis by Zhang *et al.* (2021) showed that the frequency values decrease as the damage progresses in the samples.

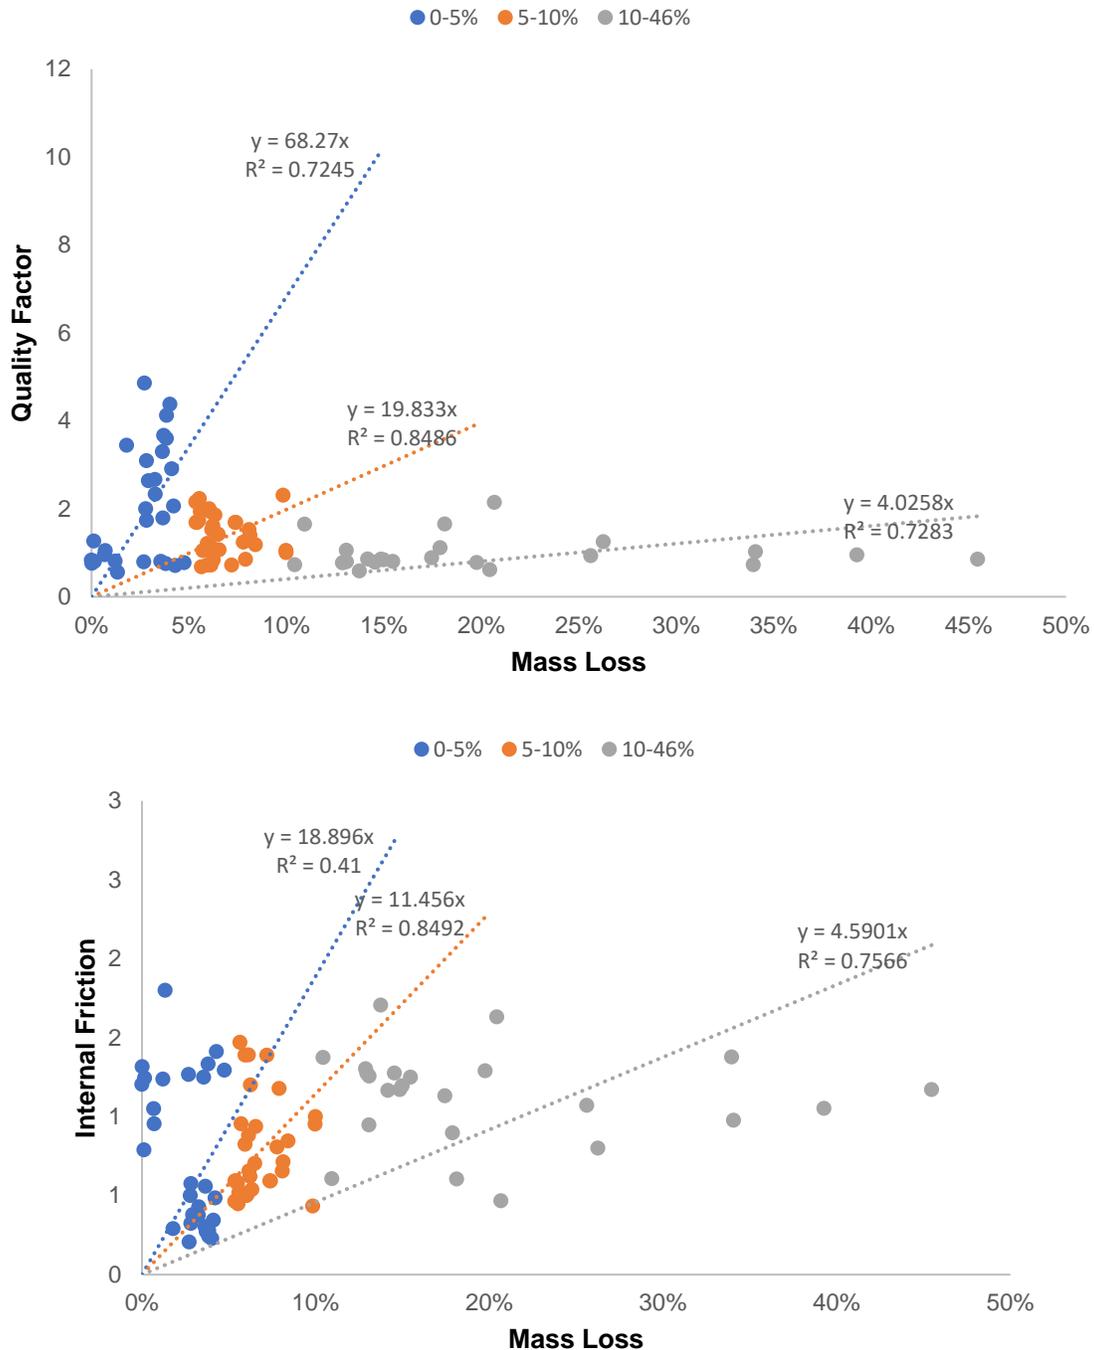
Fig. 16. Quality factor values *versus* the mass loss percentage at different levels of 0 to 5%, 5 to 10%, and 10 to 46% mass loss

The internal friction and quality factor values *versus* mass loss percentage are presented in Fig. 17. Sample orientations (edge, end, and face) exposed to termite damage had a significant difference effect (Table 2) on quality factor and internal friction values 0.01 level ($p = 0.031$).
