Review of the Current State of Application of Wood Defect Recognition Technology

Yutang Chen, Chengshuo Sun, Zirui Ren, and Bin Na *

DOI: 10.15376/biores.18.1.Chen

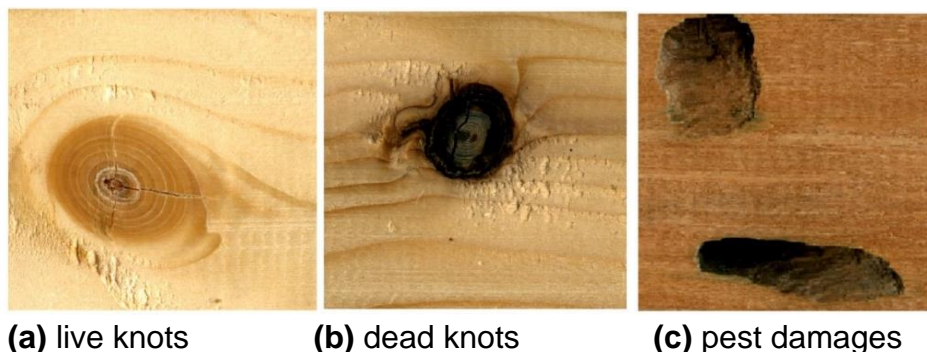
Fig. 1. Major wood defects

The main growth defects in timber are knots, cracks, slashes, burrs, resin capsules, *etc.* Most of these defects are due to the normal growth of the tree. However, from the perspective of wood panel utilisation, these are wood defects. Of these, knots are divided into live knots, as shown in Fig. 1a, and dead knots, as shown in Fig. 1b.

Defects caused by various pests are known as wood pest damage, which is mainly manifested in the form of holes and grooves in wood cuts, as shown in Fig. 1c. Pest damage that involves eaten round timber to a radial depth of less than 10 mm is known as surface holes and grooves. Holes with a minimum diameter of less than 3 mm are known as small holes, and holes with a minimum diameter of 3 mm or more are known as large holes. Surface pest holes and grooves can often be removed with the veneer and therefore have little effect on the use of the timber. Scattered small pest holes have little effect, too. However, large holes with a depth of 10 mm or more and deep, dense small holes can damage the integrity of the timber and reduce its mechanical properties. Moreover, pest holes and grooves are an important channel for sapwood discolouration and decay.

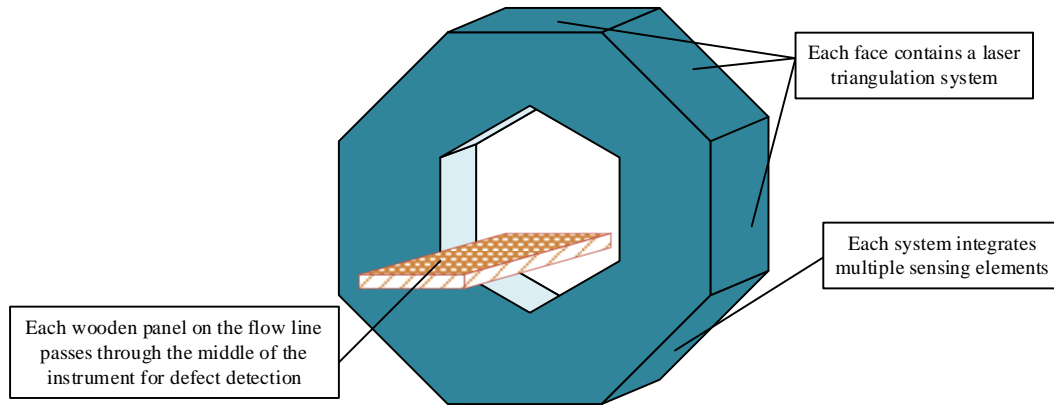
Fig. 3. Schematic diagram of multi-faceted detection architecture

Due to the high requirements for surface wood defect recognition in actual wood processing production, the advanced Nordic wood defect recognition equipment generally uses multi-angle defect detection based on laser triangulation. The advantage of this

architecture (Fig. 3) is that it enables high-speed detection of wood defects in conjunction with production lines. At the same time, these advanced wood defect recognition machines use other monitoring methods to achieve a wider range of applications and more accurate results.
